**DORLAC LAKE DAM
WASHINGTON COUNTY, MISSOURI
MO 30731**

**PHASE 1 INSPECTION REPORT
NATIONAL DAM SAFETY INSPECTION**

DORLAC LAKE DAM
Washington County, Missouri
Missouri Inventory No. 30731

6 Phase I Inspection Report
National Dam Safety Program.

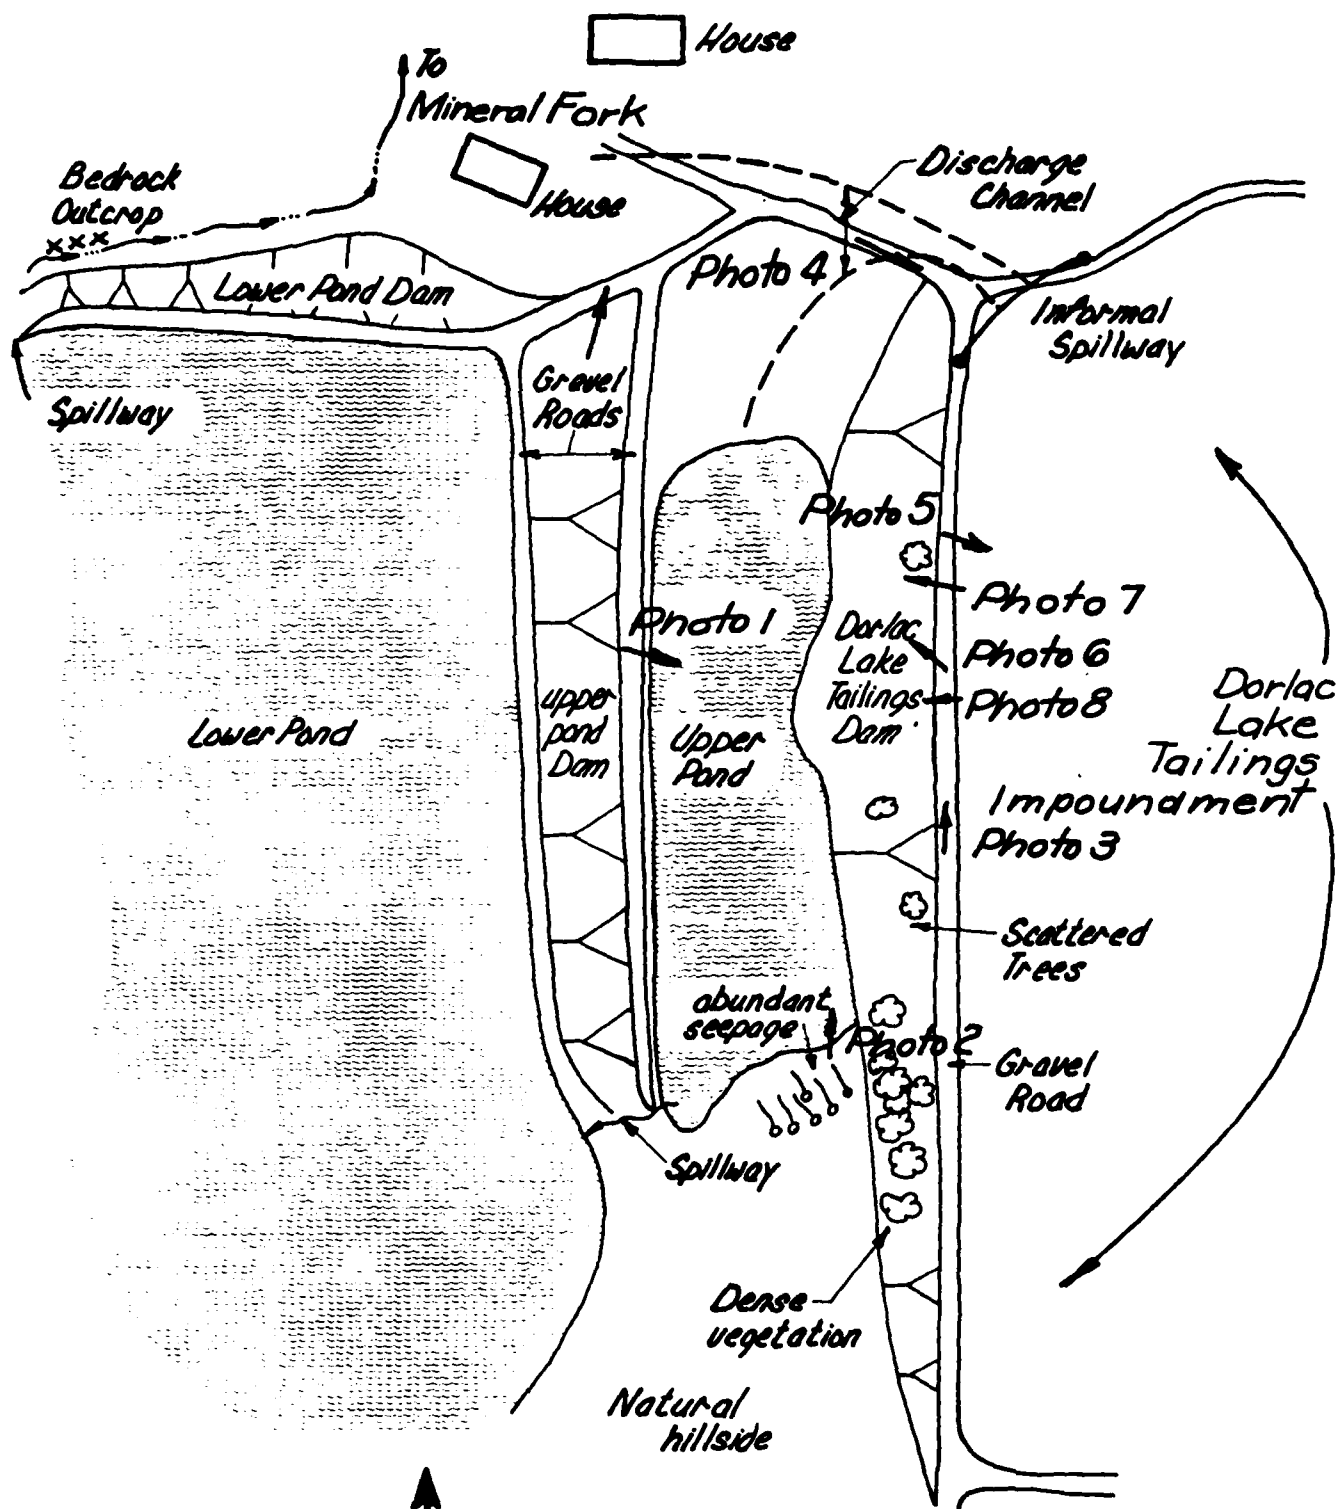
Fig. A 1

Seepage was noted along the natural hillside below the left abutment of the dam (Fig A-1, Appendix A). A broad area, perhaps 50 ft wide, was seeping into the upper pond. Total seepage was estimated at 1 to 2 gal/min. No soil was noted in the seepage water. This seepage may have been from a natural spring or seepage area, as no surface water was present in the impoundment above this seepage area.
